# *Excavation report of the VOC-ship Avondster (1659)*

The

Anglo-Dutch

East-Indiaman

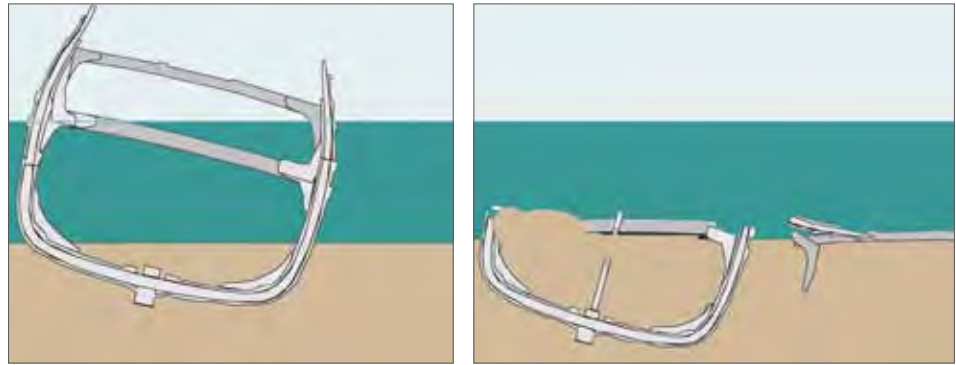
The Avondster has been stranded (left): sand flows in through the open back of the ship, the ship submerges quickly in the soft sediment near the outlet of the river. (right) The superstructure of the ship breaks off in the swell, parts of the upper deck stay together

Figure 1.4 First speculative theory for the wreck formation of the Avondster site.

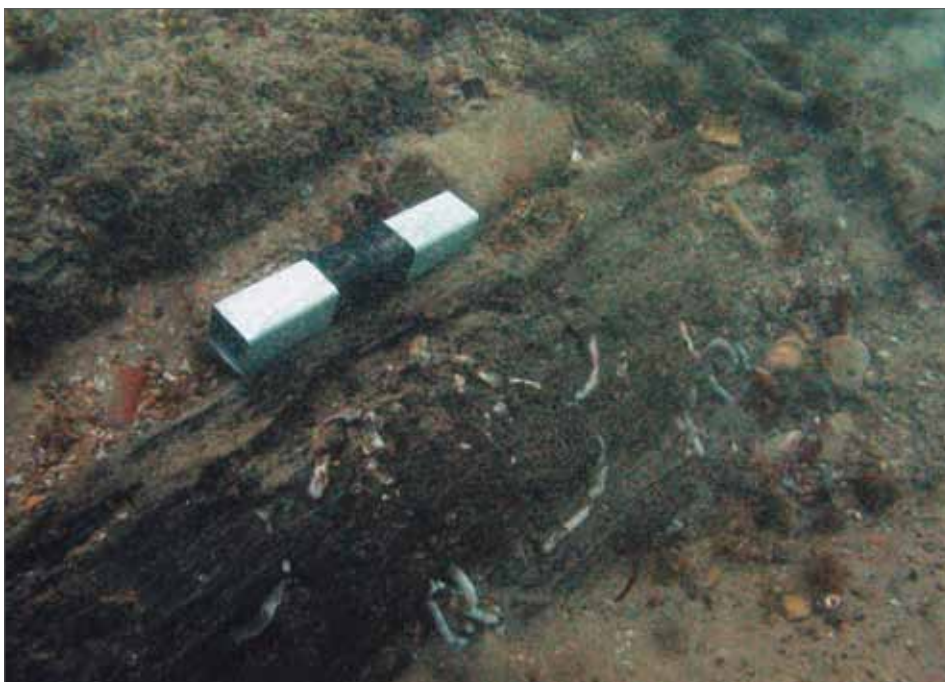
In the warm waters of the bay of Galle (up to 30 °C) biological activity is high. This means that under the right conditions, strong, solid wood may be completely deteriorated by wood-borers, like the ship worm (*Teredo navalis*) within a few months. This results in weakening of the structure, parts literally fall off and hence vital archaeological information is lost.<sup>1</sup>

Figure 10.3 Exposed oak wood in the bow section, severely attacked by shipworm (*Teredo navalis*)

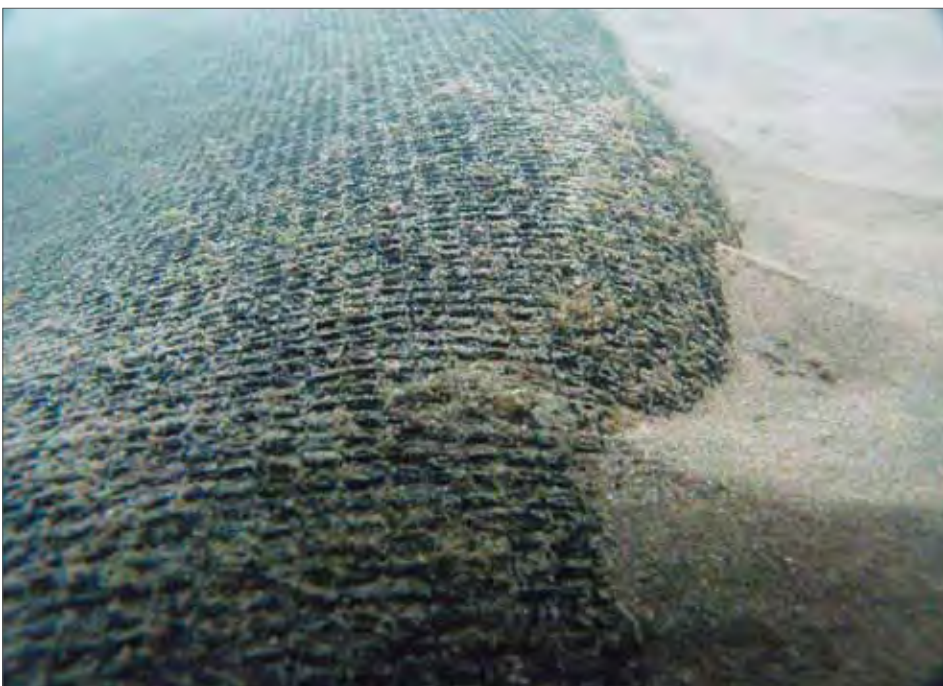
Figure 10.7 A-B First test executed on the Avondster site with shading net (woven, 100 % polypropylene and 60 % density). Old chains served as weights to keep the net down on the seabed.

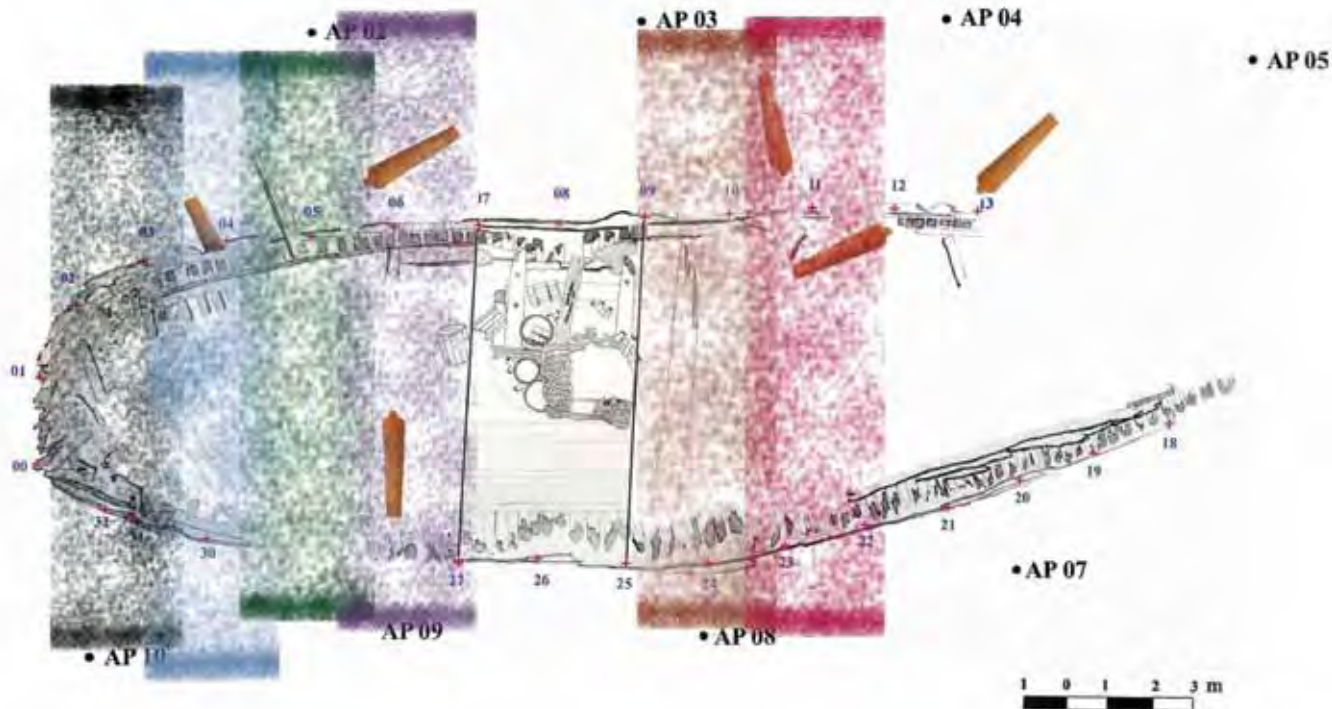
Figure 10.10 The site plan of the Avondster wreck with the projection on how the nets were laid down on the site. Drawing: R. Muthucumarana.

possibly still lying under the sand. The strips of netting were weighed down on both ends with sandbags. We chose sandbags instead of chains because it proved to be very difficult to find suitable iron chains for a low price. Old chains are re-used in Sri Lanka over and over again and are therefore, still valuable. In addition, it is not a good idea to introduce more iron to the site. Iron can increase the growth rate of marine biota thus increasing biological deterioration. The corrosion products can also impregnate organic materials increasing degradation rates in-situ and their presence can cause post conservation problems when artefacts are eventually recovered and treated.<sup>10</sup> The sandbags were half filled and rolled in the net. The different strips of net were overlapped and connected to each other with Ty-raps (cable ties), maximum 50 cm apart. Placing the nets on the site was difficult. The nets were prepared on the shore and were very heavy. It took four to six people to carry them to the boat and on each trip only four nets could be transported to the site [Figure 10.9]. In the water, it took two divers to place the nets on the wreck. With the nets still rolled up, they were laid down square in the middle of the wreck site and then rolled out to the port side and to the starboard side. The net projected an extra 4 metres past the port side and 8 metres or more to the starboard side because it was expected that more of the wreck and objects would be found there [Figure 10.10].

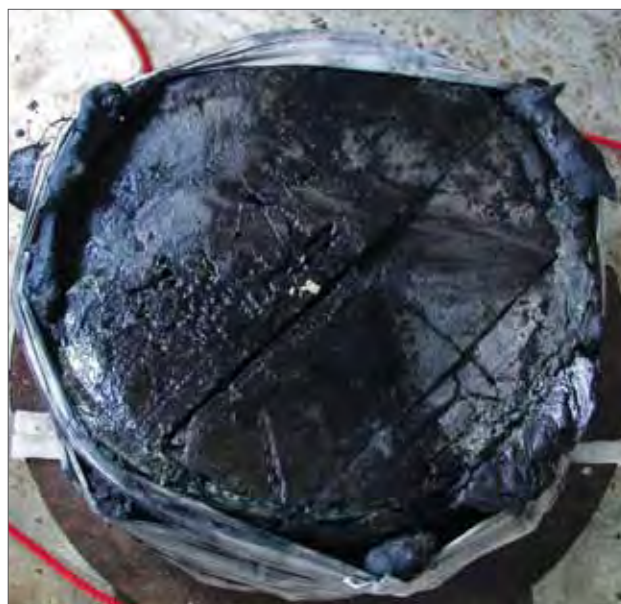
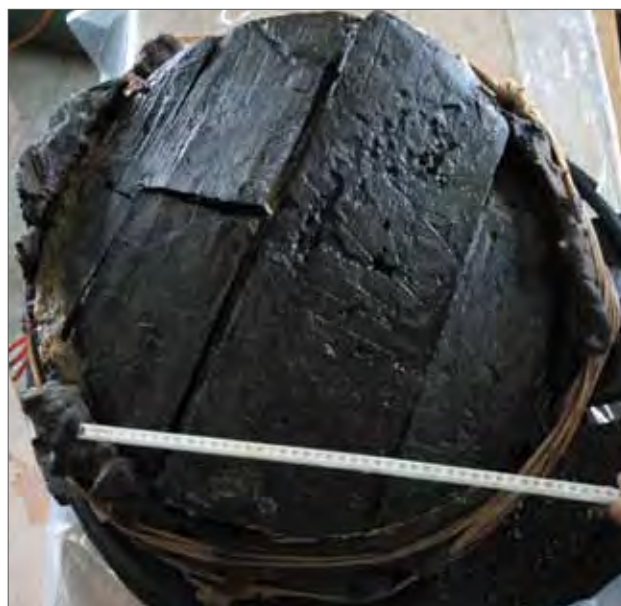
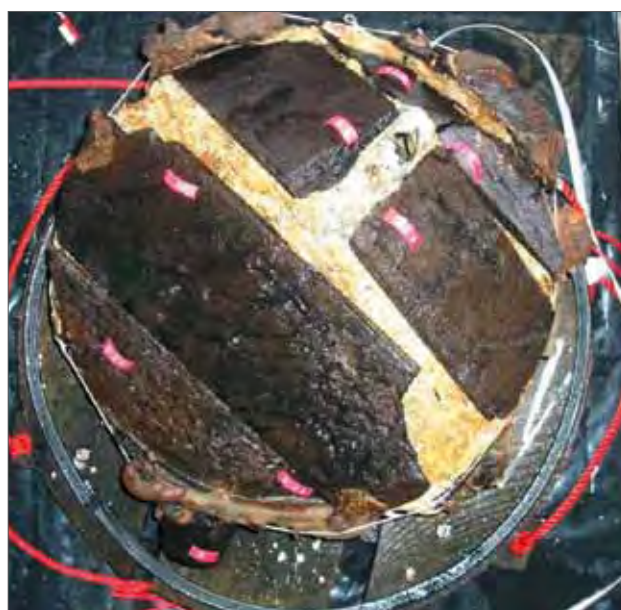
Figure 11. (9 -10-11) Time line of deterioration: the base March 2003, March 2004 and November 2004

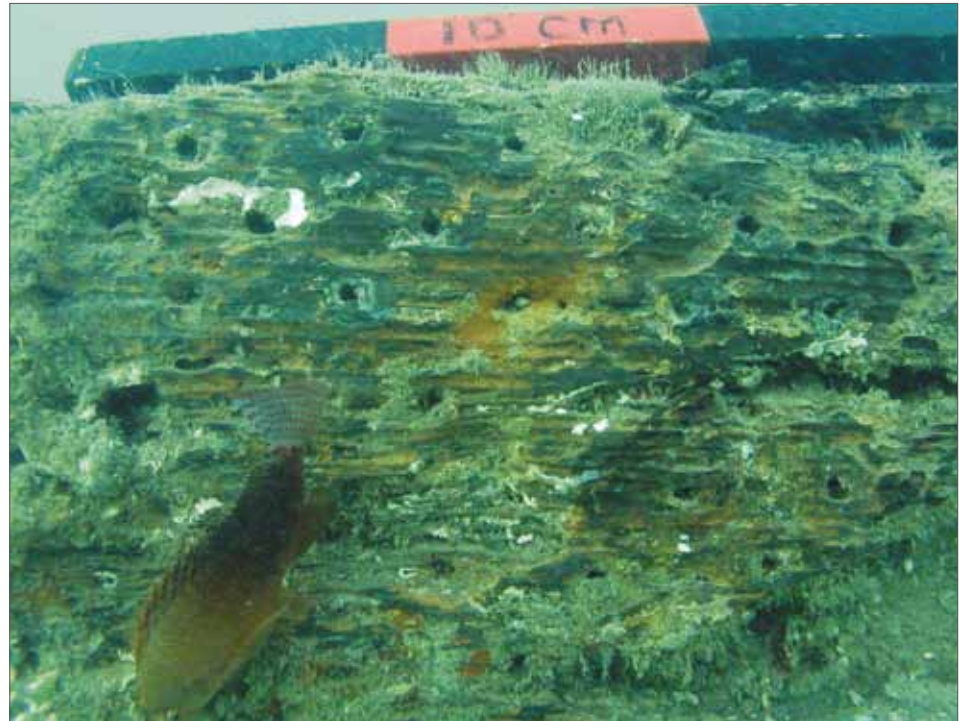
Figure 9.8 Holes left by the iron nails, now corroded away, driven in the external surface of the pine sheathing for extra protection against wood borers.

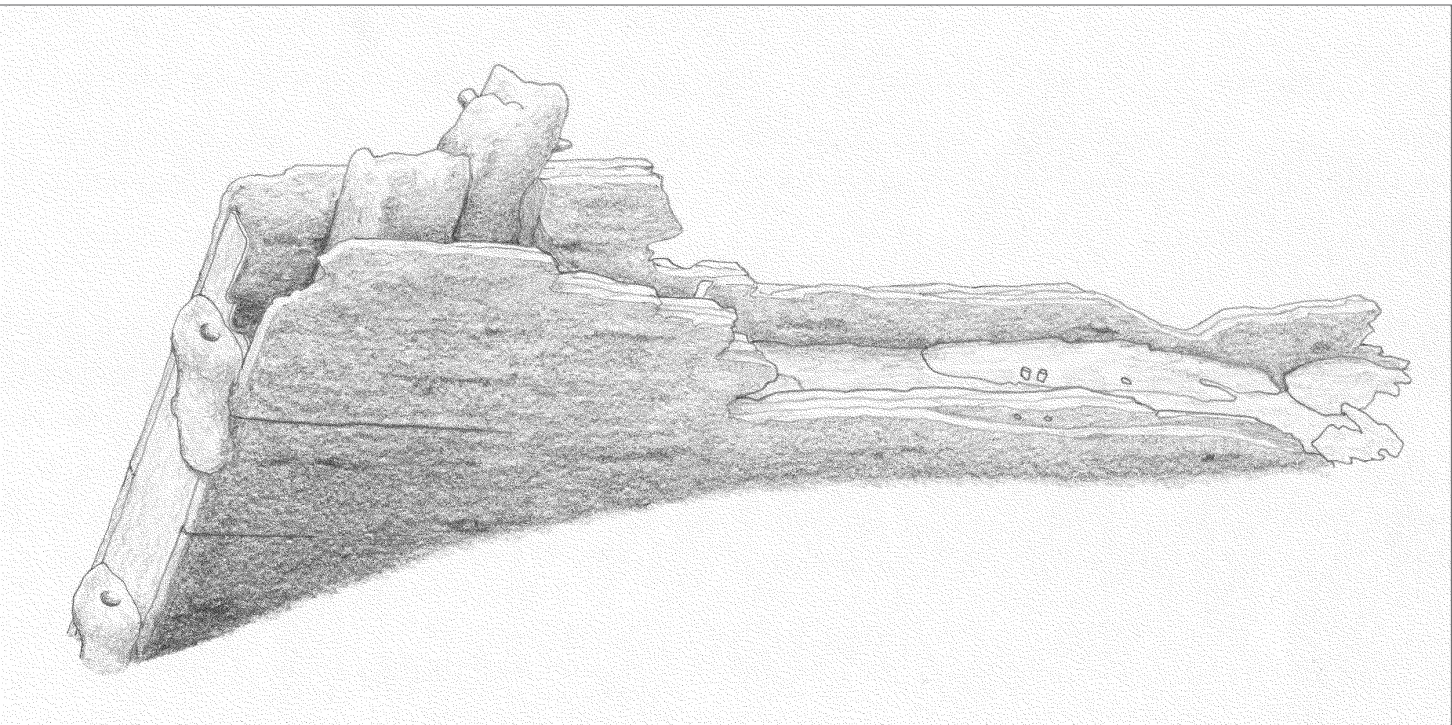
Figure 9.9. Sketch of the lower stern hull section that lies on the seabed detached from the main structure. The stern post has broken up just above the upper surviving rudder gudgeon (drawing C. Murray).

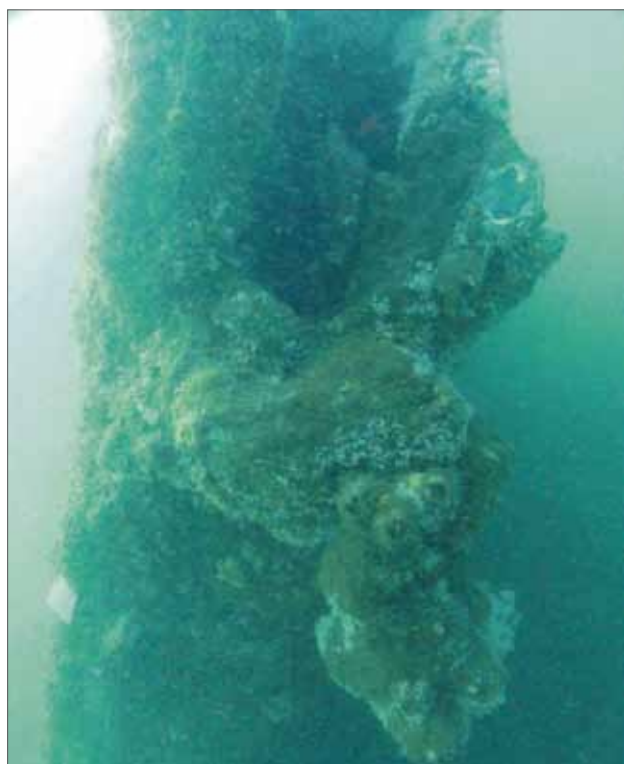
Figure 9.10. The surviving upper rudder gudgeon, heavily concreted, still attached to the sternpost .

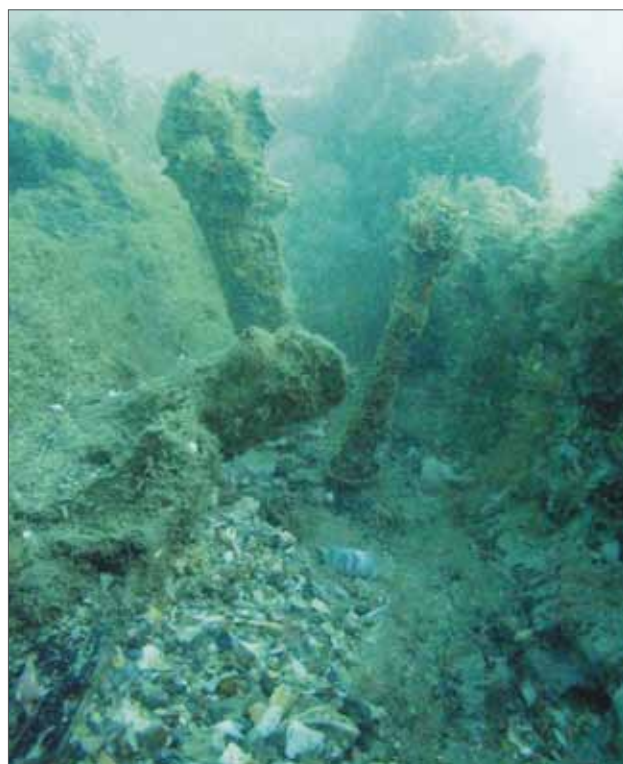
Figure 9.11. Iron bolts protruding from the wooden remains of the stern hull section, between the planking strakes.
