# *Excavation report of the VOC-ship Avondster (1659)*

The

Anglo-Dutch

East-Indiaman

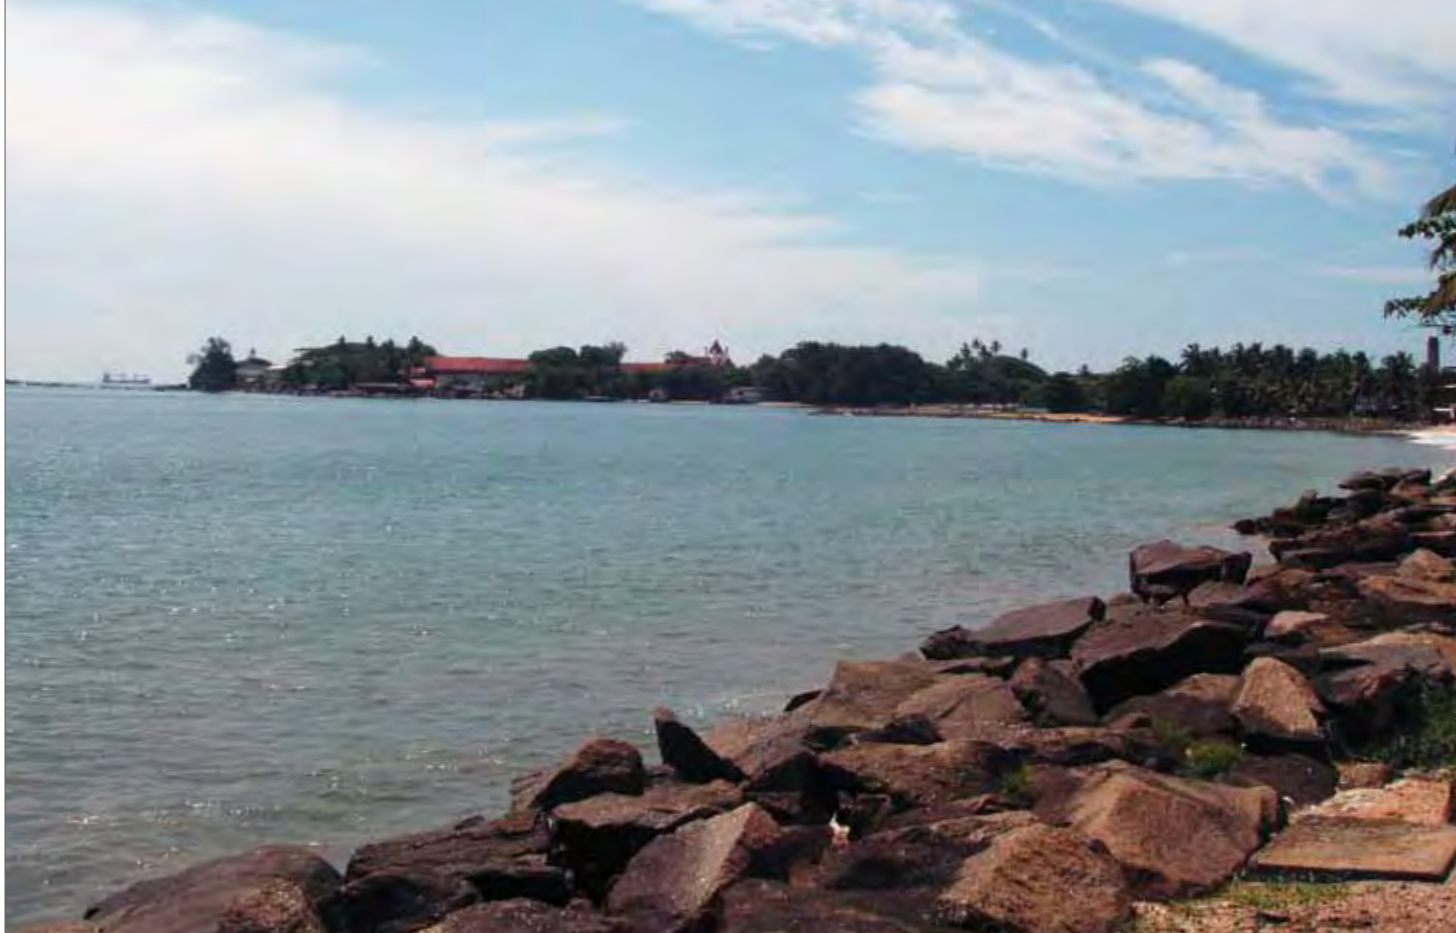
Figure 10.4 View from the stone barrier, protecting the road, towards Fort Galle and the ocean. This stone barrier is causing stronger erosion on the wreck site that is lying just about 80 metres in front of it.

The building of a road with a rock wall on the beach line only 50m from the wreck, a few decades ago, is almost certainly the reason for the stronger erosion [Figure 10.4]. The road has been built on the former beach, effectively severing the river outlet. Waves coming from the ocean are abruptly stopped against a rocky wall instead of breaking on a gradually sloping sandy coast and are then redirected out to sea again. This effect, called winnowing, creates a strong current around the wreck site, undermining the structure and removing the protective layer of fine silt and sand. Because of this stone barrier the river cannot deposit its fine sediment on the site anymore. It seems that in one decade the seabed around the wreck site has eroded dramatically. In 2003 new work was executed on the stone barrier close to the wreck. Some jetties were constructed in the water. Immediately the currents changed course and more sediment was removed from the site in places that were relatively stable prior to the new constructions. It is also possible that the seasonal excavations have had an influence on the stability of the wreck site itself. Excavating sediment and building structures on and near the wreck obviously creates different current patterns on a local scale, increasing erosion. Although previously noted on other sites, this phenomenon has not been extensively investigated.<sup>2</sup>

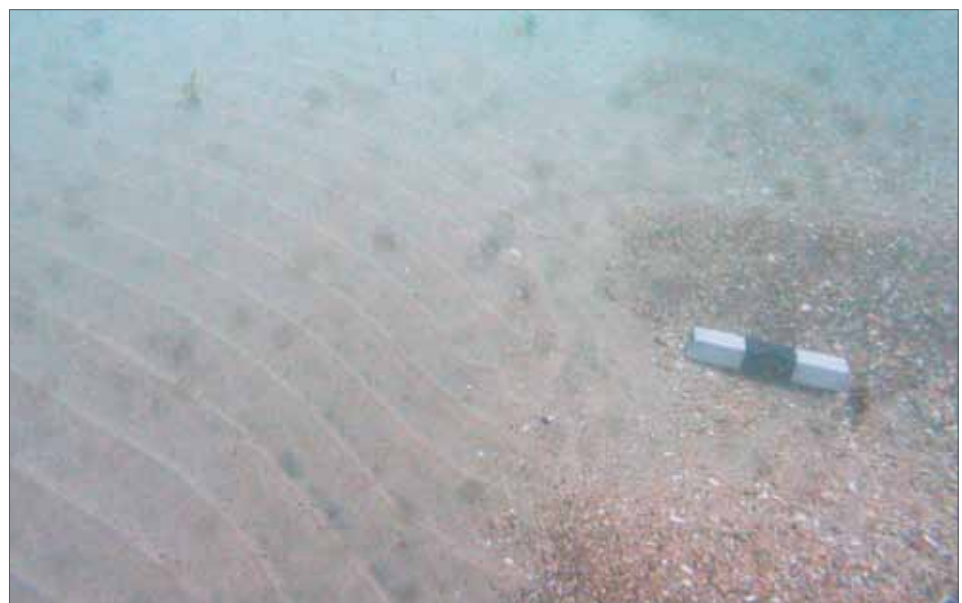
Figure 10.6 Fine and coarse sand on the Avondster site.

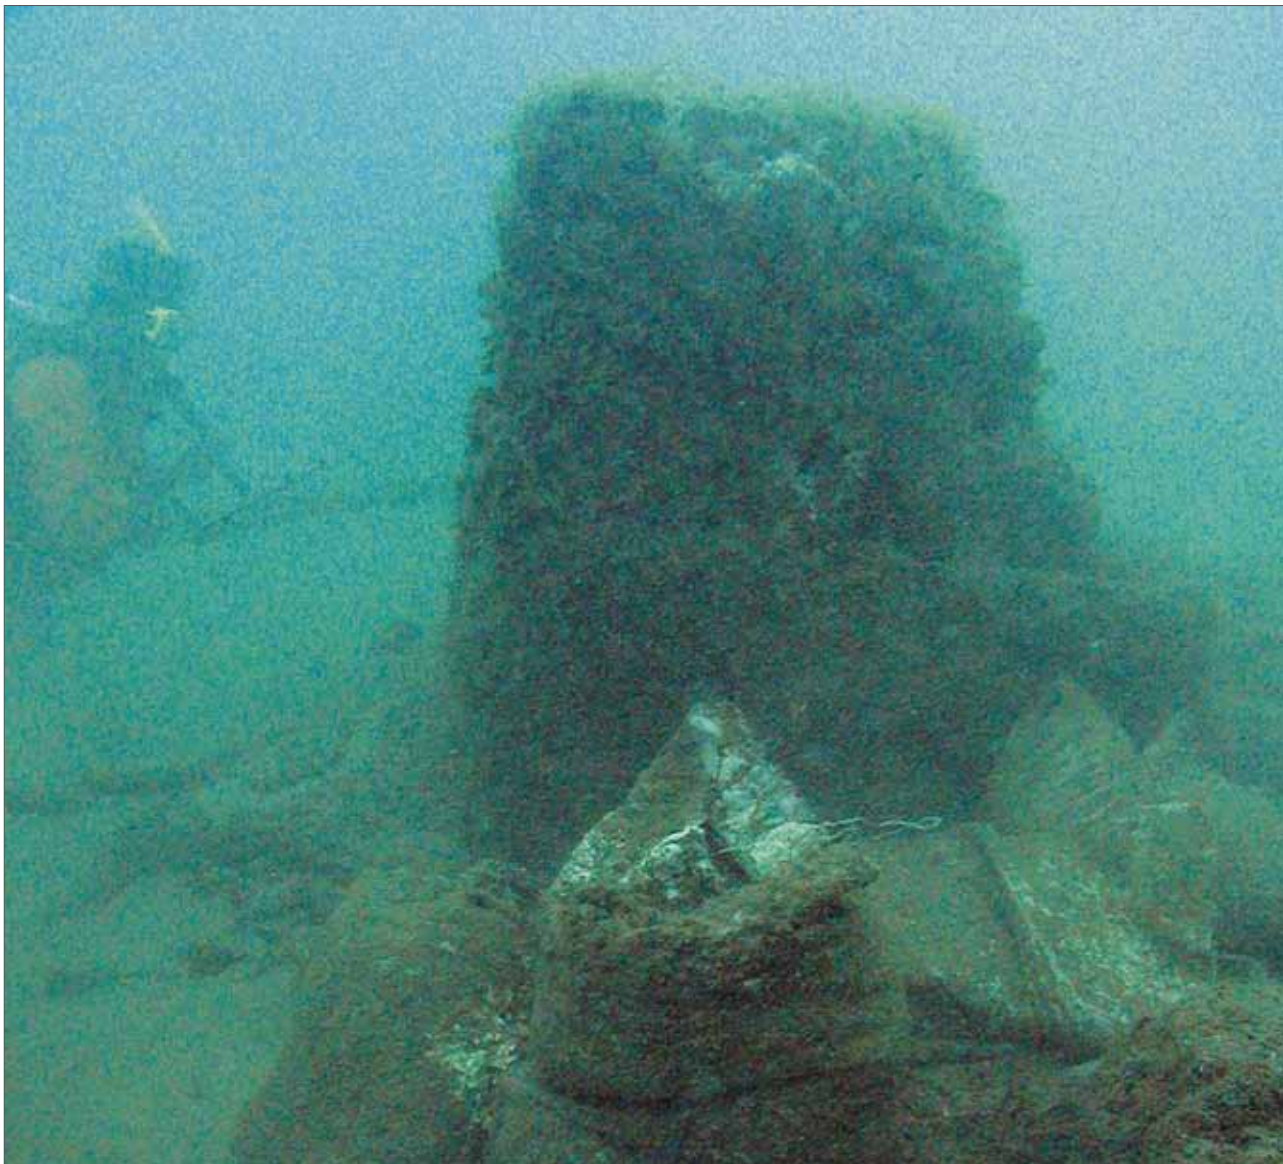
but there is also still a lot left of the ship's structure, cargo, inventory and personal belongings that is worth protecting. The galley and the stern section are protruding a few metres above the seabed [Figure 10,11]. It will be impossible to cover them with polypropylene nets at this moment as well. We propose the following: To lay the nets around the galley, while the brick stone structure should be well reinforced with sandbags. Maybe, after the whole site has been buried under a layer of sand, attempts can be made to cover the galley as well. At this time, the height differences are too large. The stern section is laying a few metres away from the rest of the ship's structure. Possibly the best thing to do is to raise the stern section from the seabed, investigate it, conserve it "ex-situ" and exhibit it afterwards in the new maritime museum in Galle fort.<sup>11</sup>

Figure 10.11 The galley is sticking out a few metres from the seabed.

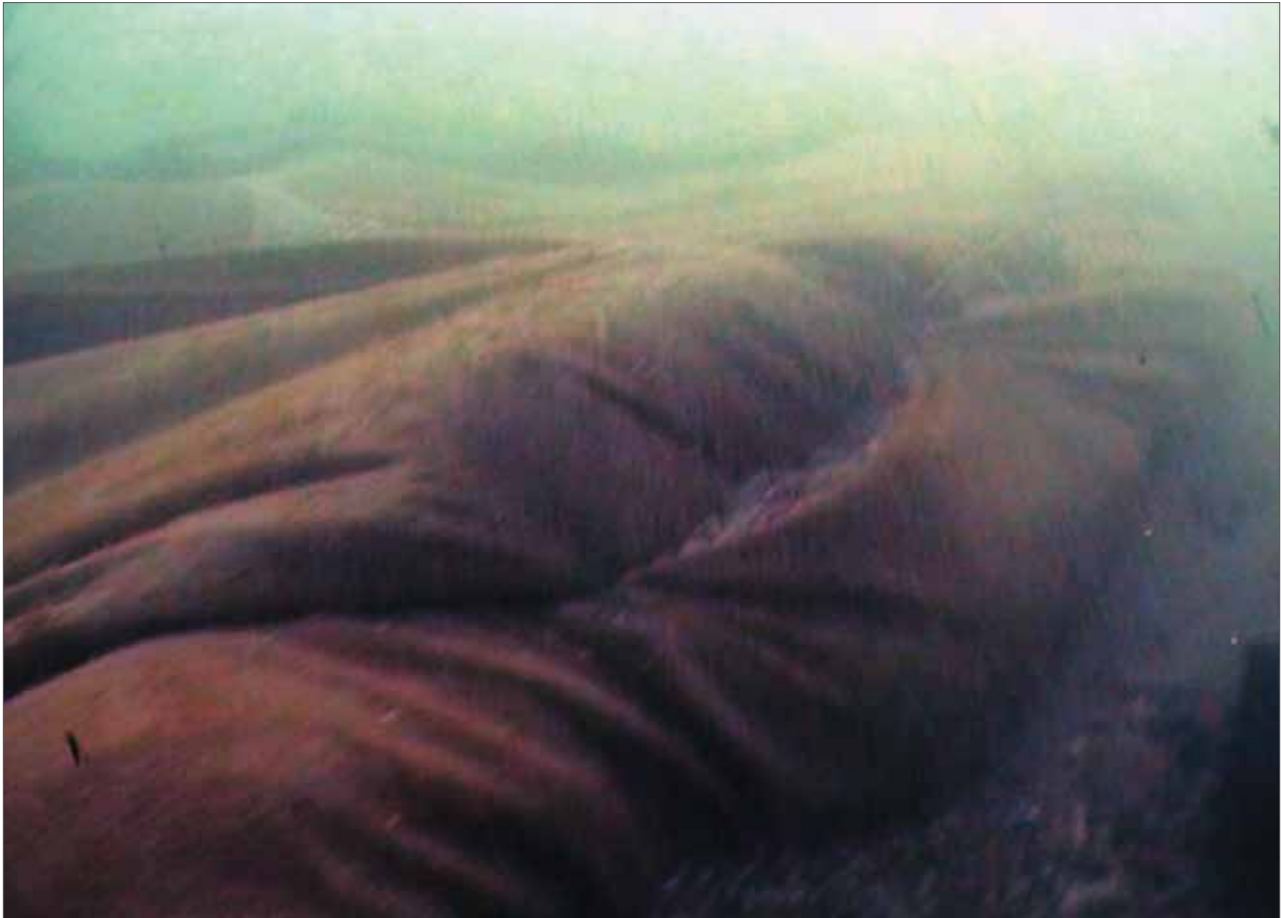
On the 26<sup>th</sup> of December 2004, a Tsunami hit Galle Harbour with incredible force. It was thought that it would have affected the conditions on the site. Eye witnesses state that just before the big wave entered the Galle Harbour the wreck itself became exposed (Jeffery & Muthucumarana 2005, p. 3). Surprisingly, monitoring in April, three months after The Tsunami, revealed that hardly any damage was done to the wreck site and its protection [Figure 12]. The covered bow site was still covered with a thick layer of sand. It shows us that even under extreme conditions the protection seems to be effective.

Figure 10.12 The nets and how they are lying on the wreck site now. It is clear that, even after a Tsunami, they are still holding sand on the site. The protection method works extremely well.

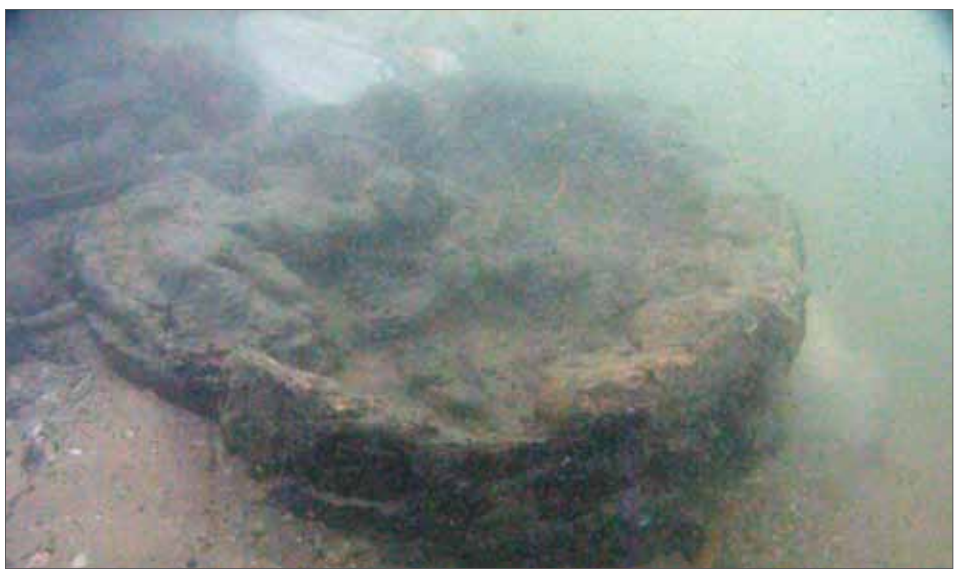
During the fieldwork season of March 2003 an intact barrel was uncovered on the wreck of the Avondster. The top of the barrel had become exposed above the sediment line and wood previously covered was now unprotected (Figure 11.3). After consultation between archaeologists and conservators a decision was taken to raise the barrel.

Figure 11.3 The barrel in-situ

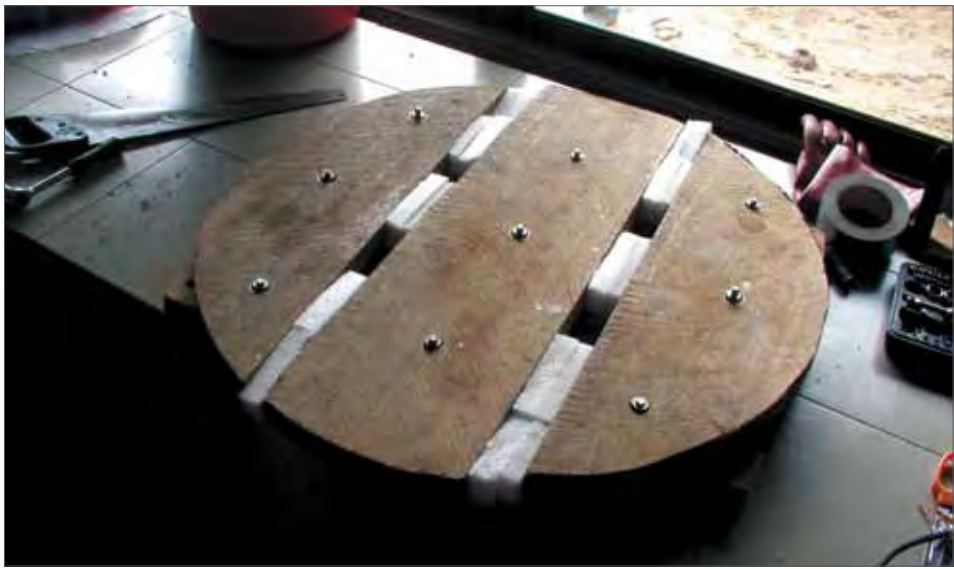
Figure 11.4 Disc support for the barrel

Due to its fragile condition, a support was designed and built to ensure the barrel was physically stable and adequately cradled during conservation treatment, a process which necessarily involved lengthy immersion. Upright, the 50kg weight of the barrel was taken by the soft degraded wood of the base. Due to the poor condition of this wood; it was decided to invert the

barrel so that the weight would be supported by the solid 'concretion' and contents of the barrel instead of the fragile base

Due to the weight and awkward size of the barrel a number of people were required to lift and handle it. Archaeologists and conservators worked together to design a container suitable for storage, lifting, handling and treatment of this object. A large disc was constructed from timber, timber batons were attached to the underside with stainless steel bolts (Figure 11.4). This disc was designed to support the barrel during treatment and to bear the weight when handled. A lifting system was designed by conservator Kamal de Soysa in which the disc was attached by nylon rope to a weighted pulleys system attached to the roof structure (Figure 11.6). Using this system the barrel could be lifted from the storage-treatment tank in a controlled and safe way.

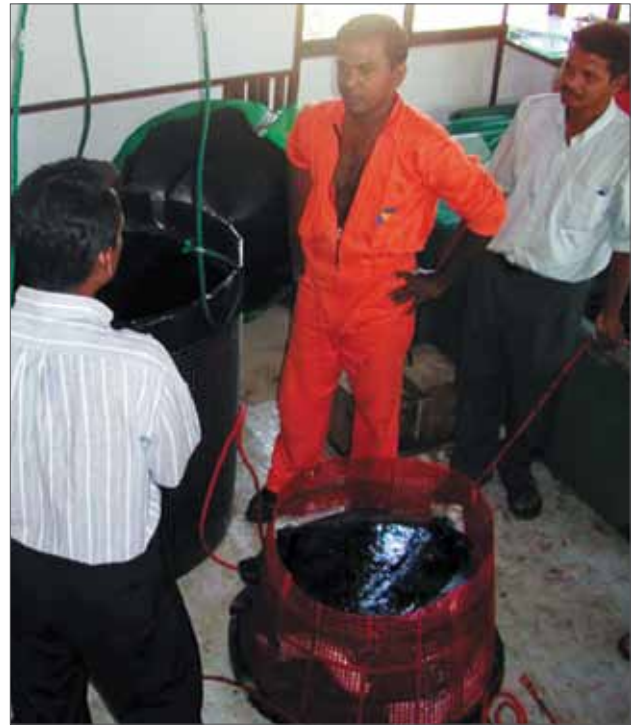
Figure 11.8 The barrel with the support system

As it remained unclear how sound the barrel structure was, precautionary measures were taken to support the staves of the barrel by constructing a light frame around it. In-situ the barrel was supported by the sediment. To provide support out of the sediment, the elastic pharmaceutical bandages used for excavation were removed and reapplied to provide even coverage and light support to the barrel.

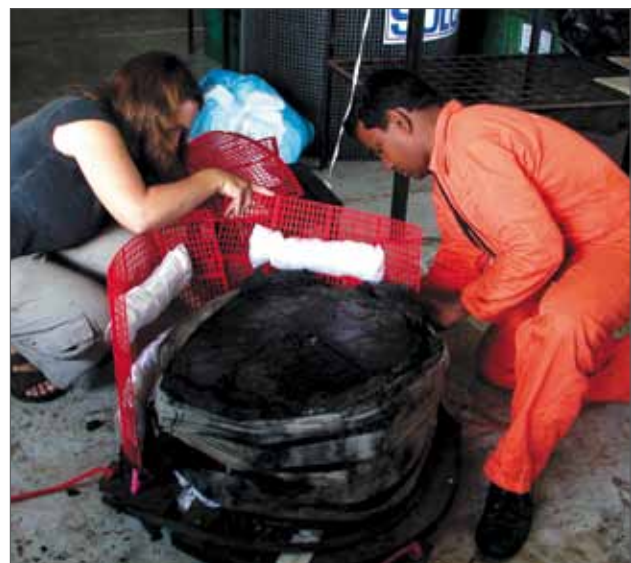
Figure 11.7 Protecting the barrel staves

Plastic mesh sheeting (a plastic basket cut into sections) was placed around the barrel to provide additional support. The interior was selectively padded to ensure a good fit and to prevent abrasion of the barrel surface. The mesh sheets could be removed in sections to allow monitoring of the condition and surface cleaning without removing the barrel from the support. Polyester fabric and wadding was used as the padding material as it would not degrade in the aqueous storage & treatment solutions (Figure 11.7).

The inverted barrel was placed on the padded wooden disc, with the weight of the barrel supported by the 'concretion'. Additional padding was added where any wood remained at the concreted 'top' of the barrel.

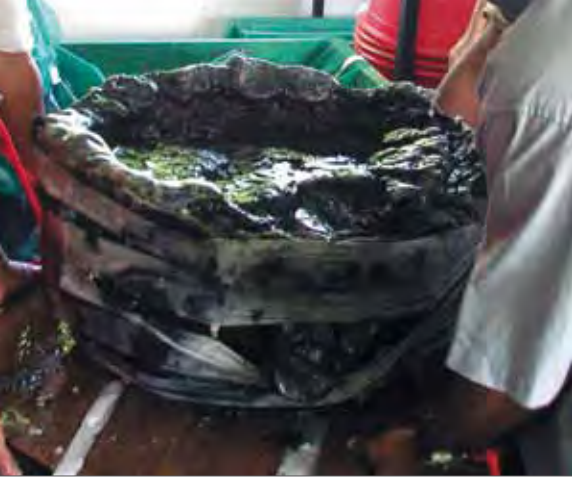
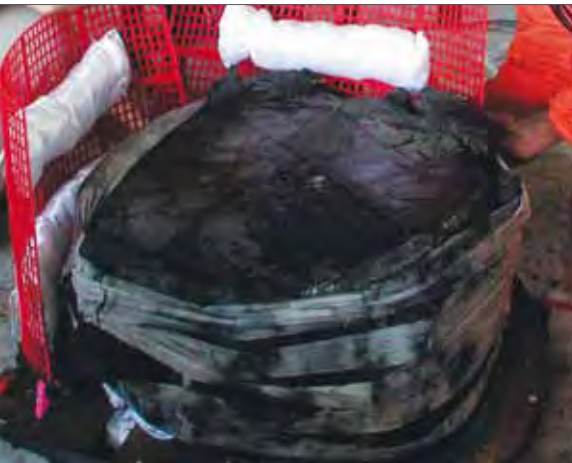
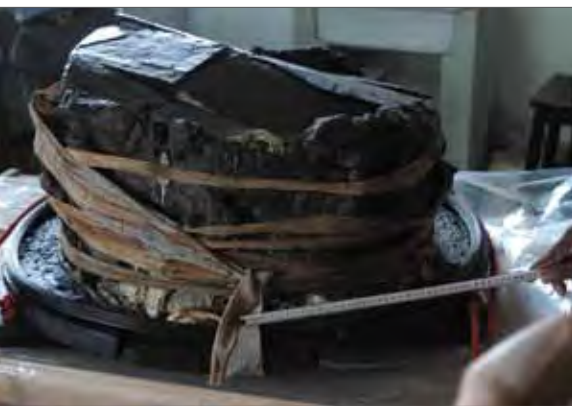
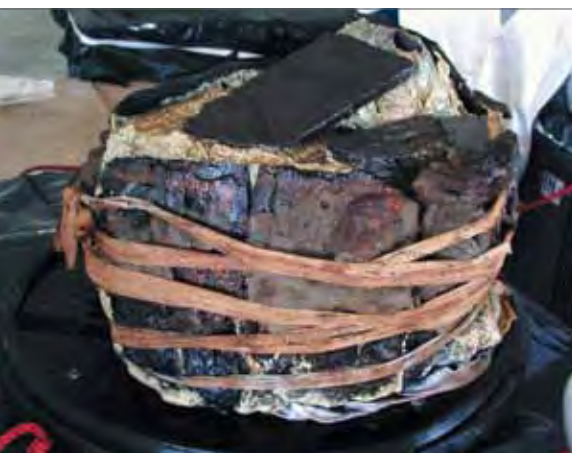
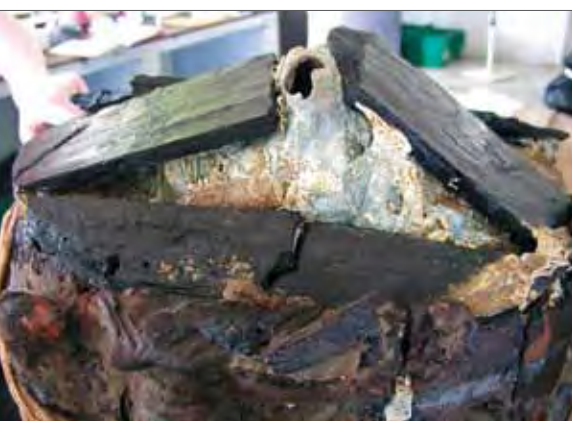
Figure 11.12 ( A -E ) Time line of deterioration: the staves March 2003, March 2004 and November 2004; ( E ) shows the movement of resin caused by an air bubble

In March 2004 an assessment of the barrel showed the following effects of this resin flow: the flow of the resin was stronger than the remains of the iron hoops and wooden staves, causing the staves to separate as the resin began to seep through the gaps the movement of the resin was affecting the stability of the wooden base, with the dowelled pieces separating and the wood beginning to fracture

continued flow of the resin had caused such serious structural changes to the barrel that it was no longer considered possible or safe for the barrel to remain as an intact entity (Figure 11.12 A-E). The decision to dismantle the barrel was not taken lightly.

The movement of the resin had deformed the barrel completely, with significant movement of the staves and the base. The corroded and concreted hoops had started to crack, the staves had begun to separate and an increased amount of resin was oozing through. The pieces of the base (on the top due to the previous inversion) had been forced upwards, on an angle, with a large surface of resin newly exposed. A large 'air' bubble formed within the resin had forced resin upwards, causing the lifting and angled movement of the base wood components. By the time the bubble had reached the surface only a thin shell of resin remained, which had subsequently shattered (Figure 11.12 E). The interior of the bubble was irregular, but measured at over . Although the exact cause of the bubble formation is unknown, two theories have been suggested: either air had been trapped inside the barrel before the ship wrecked or the resin underwent deterioration that caused the production of gas.

In summary the resin had been under the influence of two forces: 1) the natural gravitational flow of the resin, downward and spreading outwards and 2) the movement of the trapped gas bubble – directly upwards – which forced the resin upwards too.

Following discussions with the Project Director, the project consultants and the MAU conservation team, it was decided to dismantle the barrel, treat each material separately, and after conserved, reconstruct the barrel with aid of an internal support such as a customised acrylic structure.

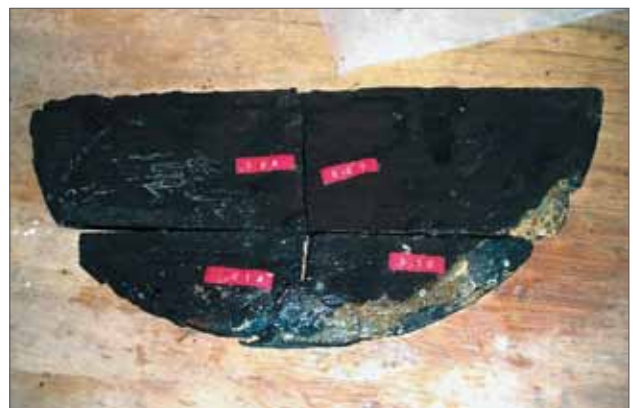
Figure 11.18. A staff after separation from the barrel

The wooden staves were not homogeneous - some areas were more degraded (soft like sponge) than others (in some areas the wood was very solid and coherent). The upper part of the barrel was clearly more deteriorated due to its exposure (to aerobic conditions, surge, borer attack, etc.) showing gloss, fractures, perforations, teredo galleries, etc. The wood of the base was more solid but the pieces had separated from each other and fractured due to the movement of the resin. The movement of the resin also caused fractures in some of the staves. After the removal of all the concretion the wooden pieces were separated from each other and from the resin (Figure 11.17). The first to be removed was the wood of the base of the barrel,

which was located on the top of the artefact. In areas this wood had already separated from the resin – a result of the movement. In the adhered sections, the wood was removed by carefully introducing metal spatulas in between the wood and the resin or by chiselling the resin. The same method was used on the staves – using thin spatula blades and chiselling into the resin. In instances where the staves were not easily separated from each other, they were detached together and a polyurethane foam padding was placed in the back to retain the curve and avoid breakage. After each stave was removed, it was recorded with digital photographs, cleaned (to remove remains of resin), and placed inside a container with tap water (Figure 11.18). The resin was retained and is to be returned to the barrel when reconstructed, and can be included in exhibition. During the whole process the barrel was kept wet by constantly spraying a fine mist of water over the surface.

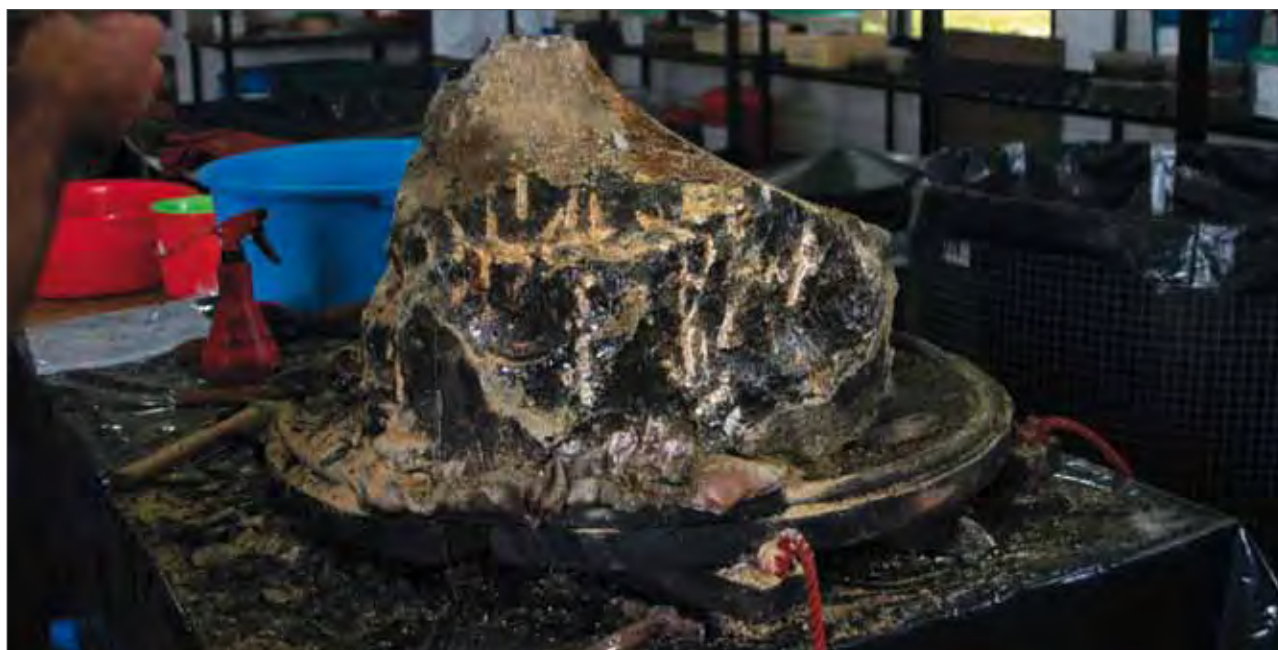
Figure 11.19. The resin of the barrel (December 2004)

A number of days after the dismantling treatment of the barrel was complete the 2004 Tsunami struck Galle Harbour. The components of the barrel were lost – the resin (Figure 11.19) was swept away, as were the concreted iron remains, the majority of the wooden components were also lost, a small number were found in the clean-up operation. It was a number of weeks before it was considered safe for staff to return to the damaged MAU premises and much of the surviving artefact material had dried in that time. The surviving barrel staves had dried and were severely deformed.

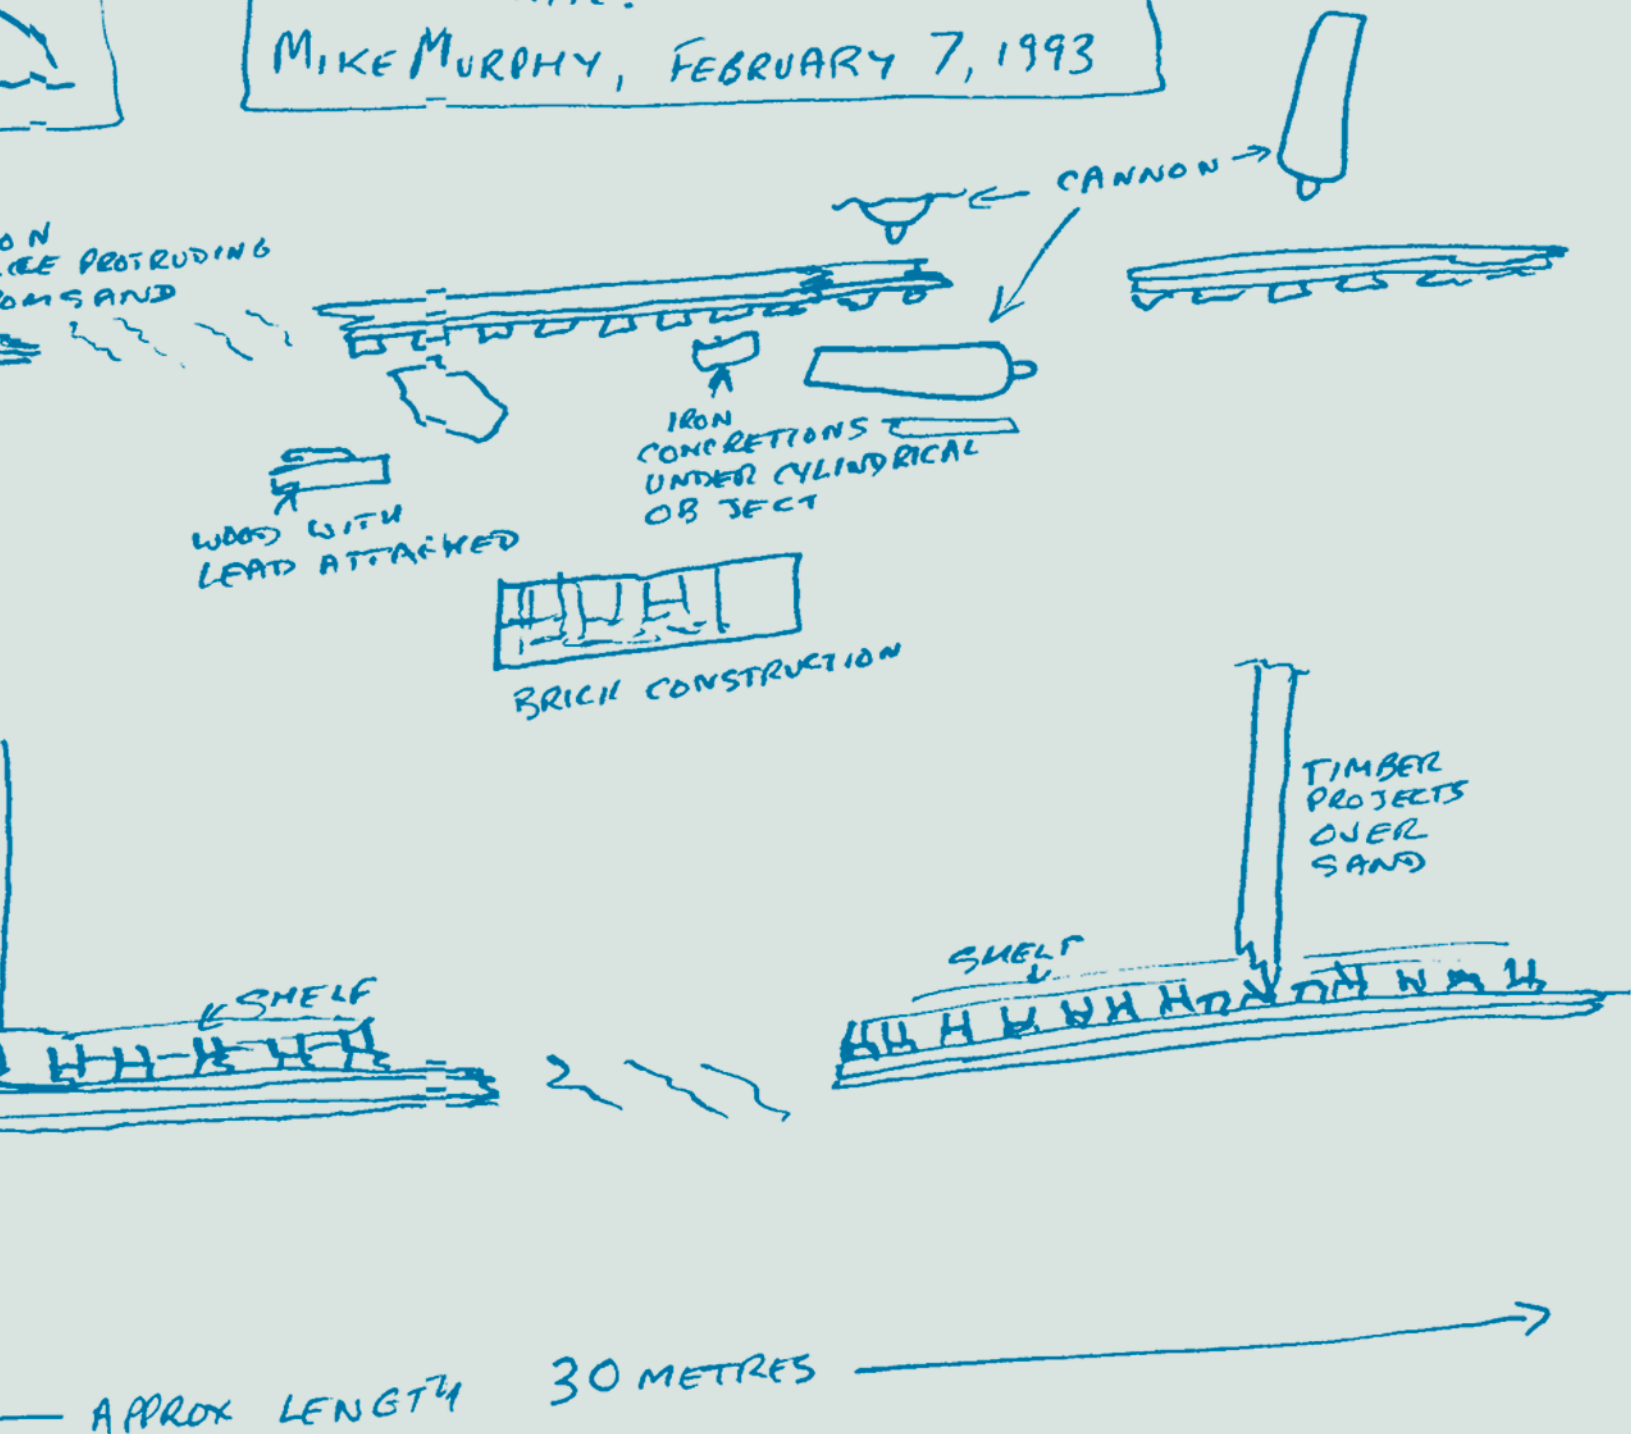
Figure 2.1 Sketch site K [sic] the Avondster site in 1993 drawing M. Murphy

After the location and identification of the wreck of the Avondster in 1993 the site was again surveyed in 1996 and in 1997. The focus of the latter surveys was to undertake a comprehensive assessment of the site, and compare to the initial sketch and description of the site in 1993 (Figure 2.1)
